I-10 New Orleans East Girder Repairs New Orleans, LA

Cofferdam/
Concrete Repairs

External PT with load
cell/welded sensors and
off-site monitoring

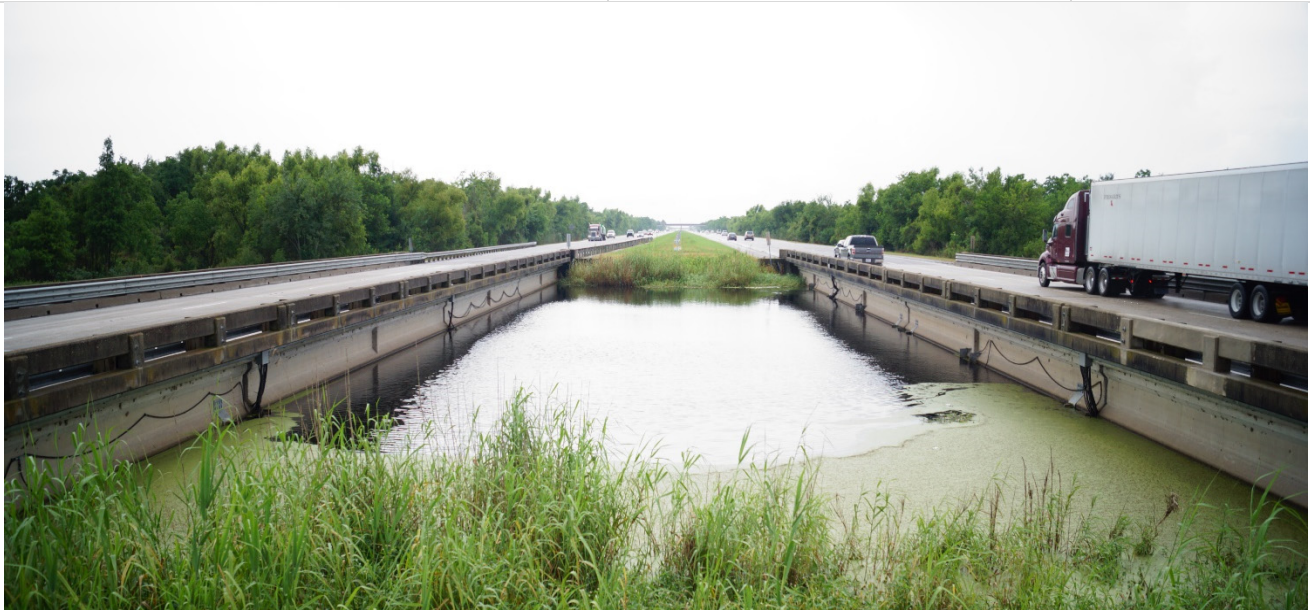
Freyssinet, Inc. was awarded the contract and executed the repair of the deteriorating concrete girders using DOT approved concrete repair material, installed External 1-1/4 inch diameter PT bars and in one span utilizing the innovative 7 wire, 11/16 inch diameter carbon fiber strand. A first time application of carbon fiber strand required continuous monitoring gauges and equipment, a system designed by Advitam, Inc. was put in place to monitor the performance of the girders and compare the effectiveness of each of the two types of external post tensioning over time. Monitoring was done remotely.

Included in this work was the installation of two water filled cofferdams designed and provided by Aquadam. The cofferdam helped to control the water level and to draw down by 5' the water level under these bridges to allow the repair crew to access and carry out the concrete repair, install/stress the PT bars and carbon fiber strands, install the load cells, weld sensors and connect electrical cables/ conduits.
